## **RICKLING GREEN PONDS**

## **BIODIVERSITY ENHANCEMENT PLAN**

*June 2022*

Prepared by Essex Ecology Services Ltd.

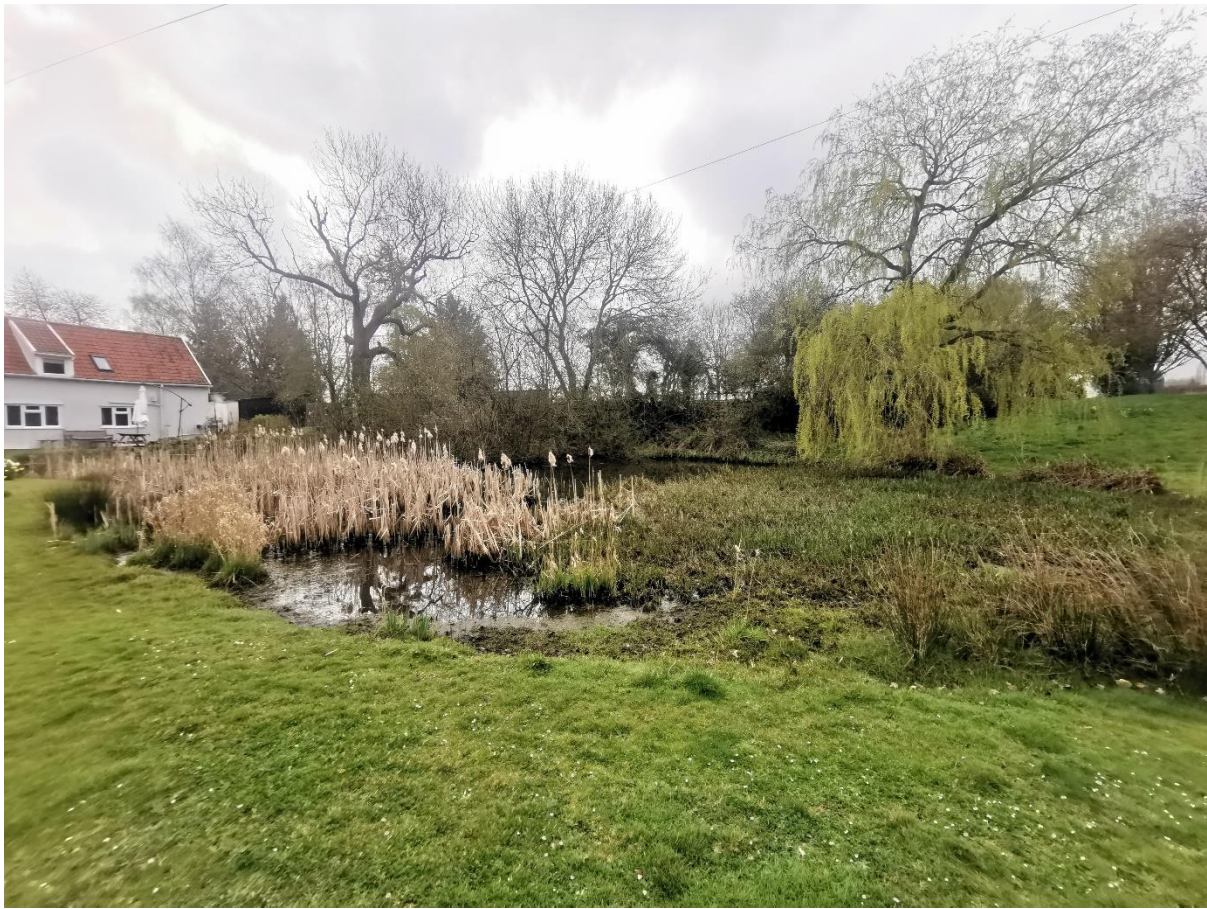
The first pond, situated at Rickling Green, is in relatively good condition. It has some trees on its southern bank and a high cover of emergent plants, with Iris, Soft Rush and Pendulous Sedge growing in the water margins. However, it is being taken over by Reedmace and Reed Sweet-grass, which is forming a mat on the surface. Both of these species tend to become dominant and will eventually block out light in the pond.

The main inflow for the pond appears to be coming directly from the neighbouring farm. This may increase the amount of sediment and nutrients in the pond, which could leave to eutrophication.

Photograph 1. Pond 1 at Rickling Green, showing dense Reed Mace and Reed Sweet-grass.

The grassland to the north of the pond is currently overmanaged, and could be left to grow longer, with a cut in the late summer or autumn once most of the flowers have set seed, and removal of the cuttings to reduce the nutrients and encourage less dominant plants. This grassland will provide a buffer from pollutants and provide habitat for species such as newts that need longer grass to safely travel between ponds.

Thinning out Reedmace is important as it helps ensure that the process of ‘succession’ (the steady build up of silt and plant debris which results in marginal plants growing into the middle of the pond, leading to the pond filling with vegetation and eventually wet woodland) is prevented. The Reedmace will need to be rotationally cleared out. It should not all be removed at the same time, as it is still a valuable habitat for invertebrates but needs some management to stop it dominating. The best way of removing it is by pulling up the whole plant by hand, removing the roots to prevent rapid regrowth. and leaving the plants on the water banks overnight to allow any invertebrates to crawl back in the water before being removed. If removing Reed Sweet-grass by hand, concentrate on removing all pieces of the root or resprouting may occur.

If planting trees near the pond, make sure they are set well back to avoid overshadowing the pond, and do not plant species such as Willow as they can dry up the pond.

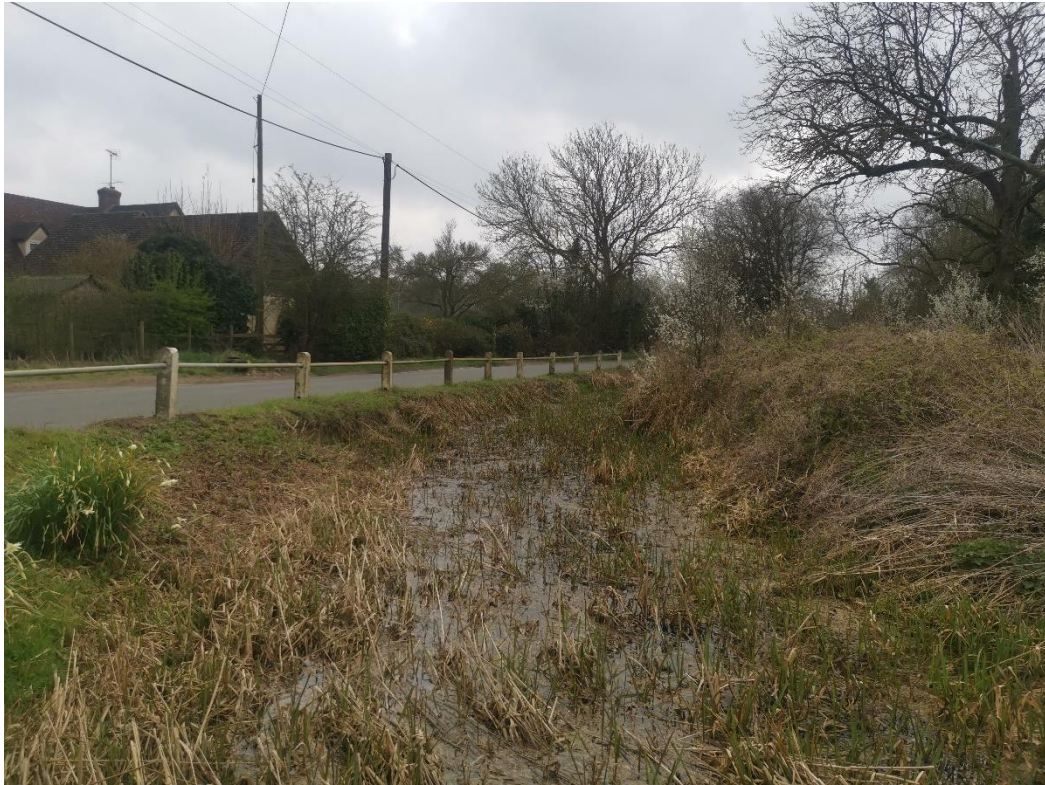
The second ponds lies to the north of Rickling Green directly next to Brick Kiln Lane. It is separated from an arable field to the south by an earth bund covered in Bramble, nettles and young Blackthorn. It was dominated by Reed Sweet-grass and had some Duckweed on the surface. At its eastern end, it backs directly onto a small area of woodland, which will cause significant shading particularly in the summer months. The water at this end had no emergent vegetation and appeared heavily silted.

This pond is likely to be affected by the input of pollutants, due to the proximity of the road and being at the bottom of the hill. There is also likely to be a runoff of agricultural chemicals into the water due to the small field margin separating the pond from the adjacent arable farmland.

Photograph 2. Pond 2, directly next to Brick Kiln Lane.

Shading reduces light for plant growth, which is likely why there is no vegetation within the shaded end of the pond. Falling leaves from trees add to the nutrients in the pond, especially tannins released from rotting dead leaves which acidify pond water. Coppicing

of trees adjacent to pond margins in late winter could be done on a rotation of several years to ensure there is always some shrub growth.

The Reed Sweet-grass is currently not completely covering the pond, but may become a problem if it spreads. It can then be managed by clearing out areas on rotation (see recommendations for Pond 1).

Late autumn is the most practical time to de-silt a pond and will cause the least disturbance to wildlife. Small ponds can be dredged by hand, but do not remove more than half of the silt in any one year to protect the invertebrates that live within it. The eastern end will require dredging, possibly every few years, depending on the build-up.

Pesticide and fertilizer often drift from agricultural fields during application, affecting plants and invertebrates. Grass buffer strips are used to protect ponds from airborne drift, nutrient leaching and runoff. Having a wider buffer strip next to the pond will maintain and enhance water quality and wildlife, by reducing nutrients and sediment. Any opportunities to widen adjacent buffer strips should be taken.

The young Blackthorn on the bund that buffers the field from the pond will need to be managed so that they do not grow too big, encroach and block out light into the pond.

The shorter managed grass next to the pond could be left to grow longer, which will provide further buffer for the pond and habitat for wildlife.
